WETLAND DELINEATION REPORT

SOMERSET COUNTY EXPANSION PROJECT SOMERSET COUNTY, MARYLAND

GTA Project No: 31191824

Re: Wetland Delineation Report
Somerset County Expansion Project
Somerset County, Maryland

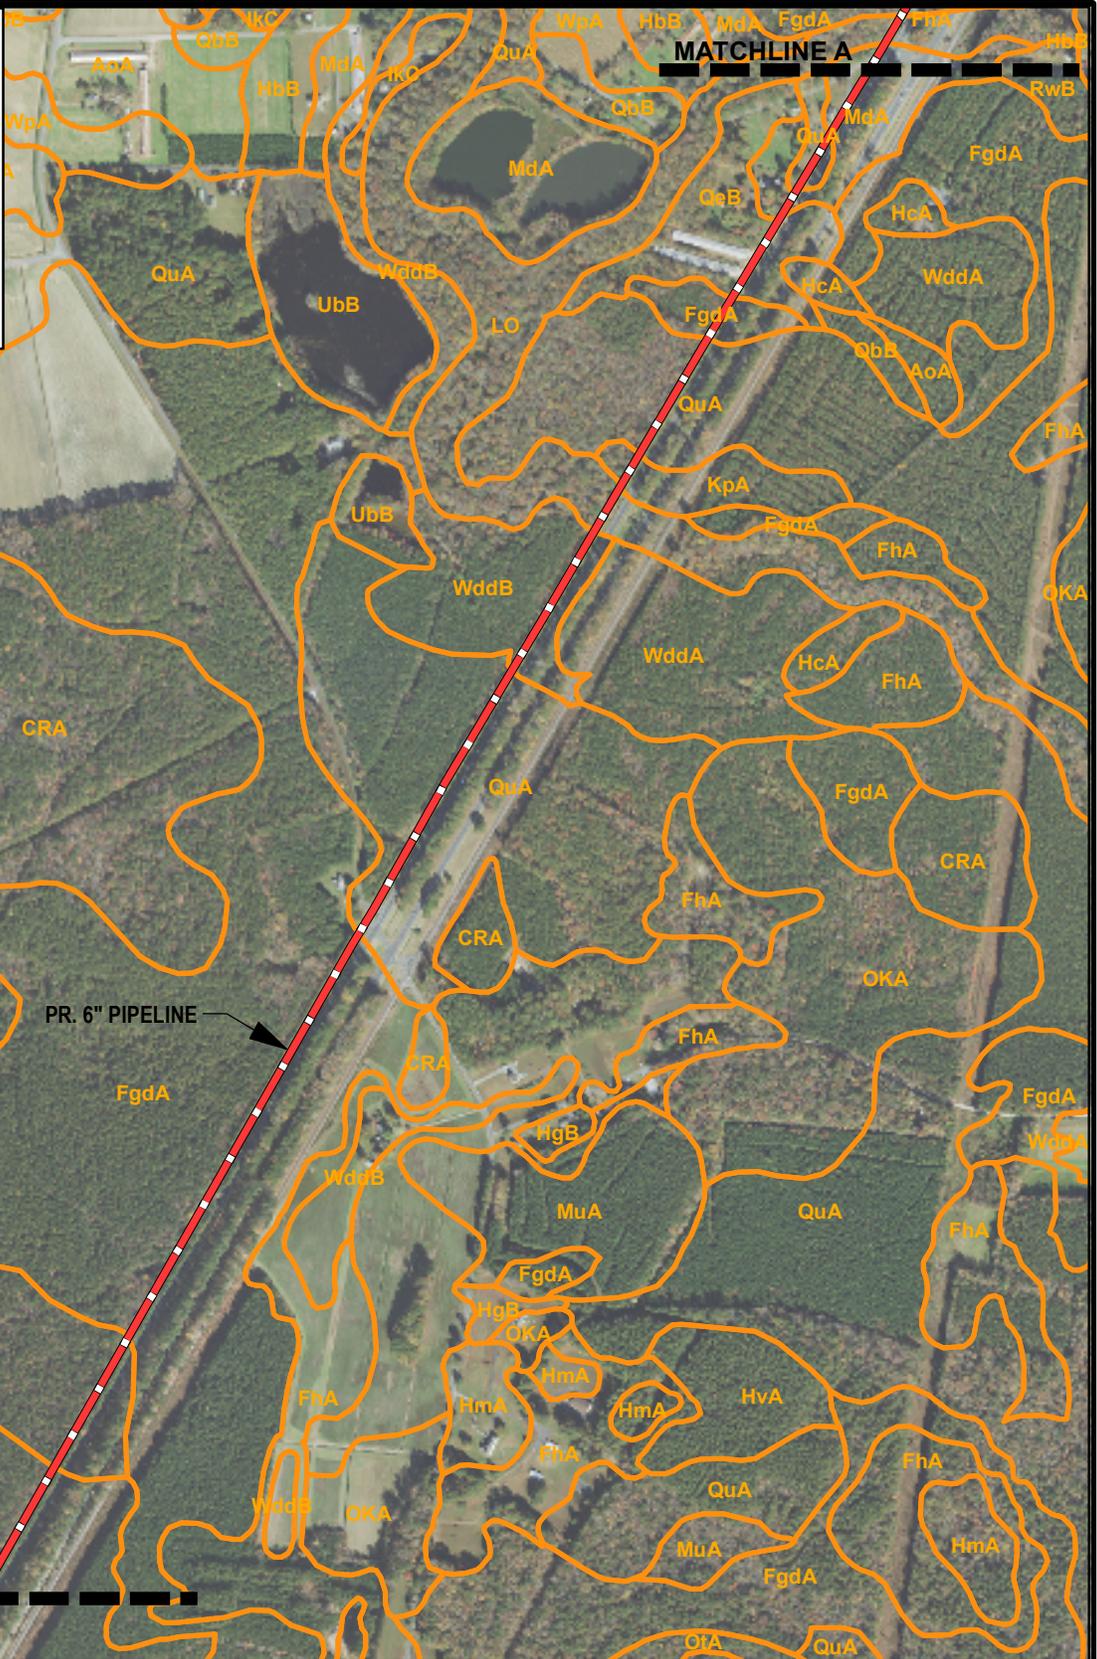
SOIL SURVEY MAP
**SOMERSET COUNTY
 EXPANSION PROJECT**
 SOMERSET COUNTY, MARYLAND

SOURCE: UNITED STATES DEPARTMENT OF AGRICULTURE, NATURAL RESOURCES CONSERVATION SERVICE. GRIDDED SOIL SURVEY GEOGRAPHIC (gSSURGO) DATABASE FOR MARYLAND. IMAP. MD iMAP, USDA

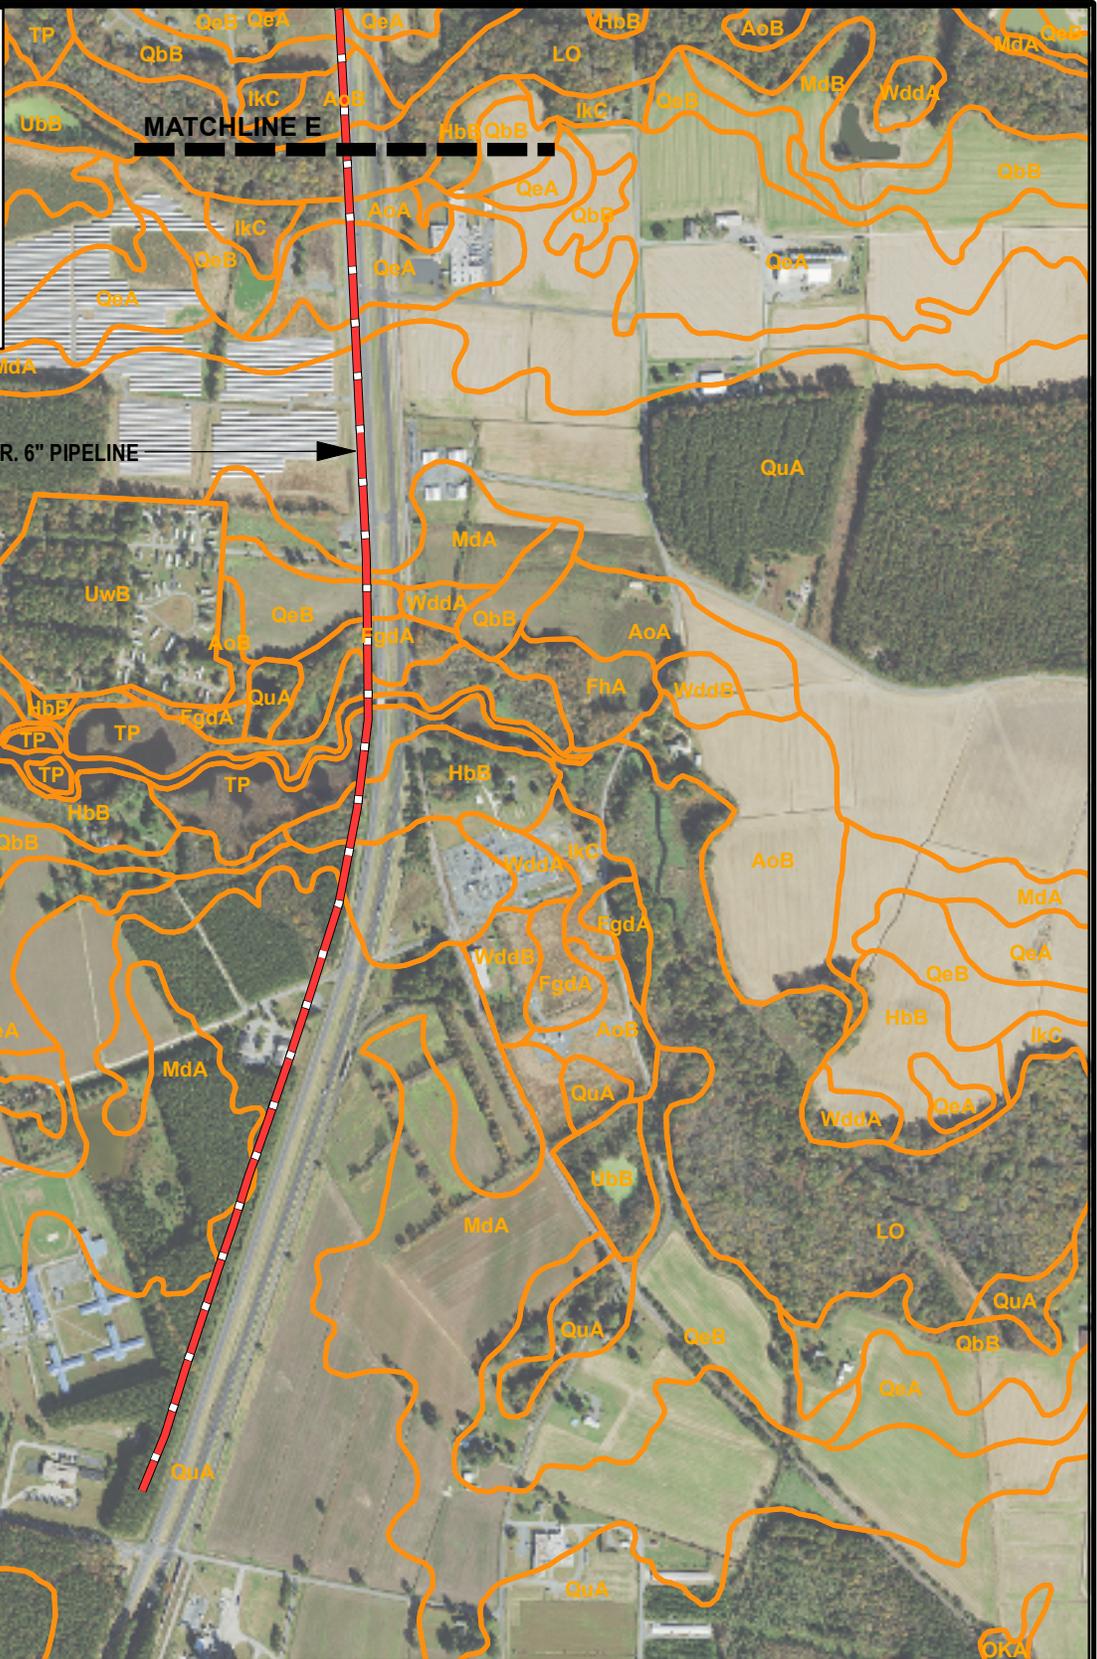
SOURCE: UNITED STATES DEPARTMENT OF AGRICULTURE, NATURAL RESOURCES CONSERVATION SERVICE. GRIDDED SOIL SURVEY GEOGRAPHIC (gSSURGO) DATABASE FOR MARYLAND. IMAP. MD iMAP, USDA

MATCHLINE E

PR. 6" PIPELINE

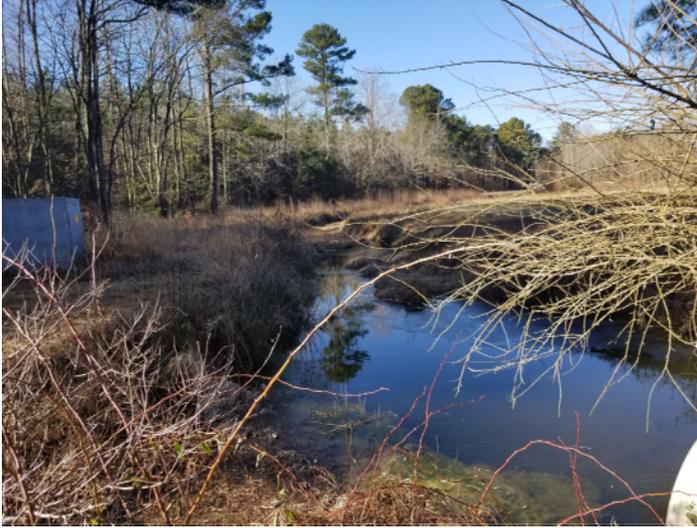
Waterbody A originates east of the project area and conveys flow through a culvert beneath U.S. Route 13 and northwest across the project area, near milepost 0.48. An ordinary high water mark (OHWM) and a defined bed and bank were observed within the limits of the stream channel within the project area.

PHOTOGRAPH 1: View of Waters A, facing west.

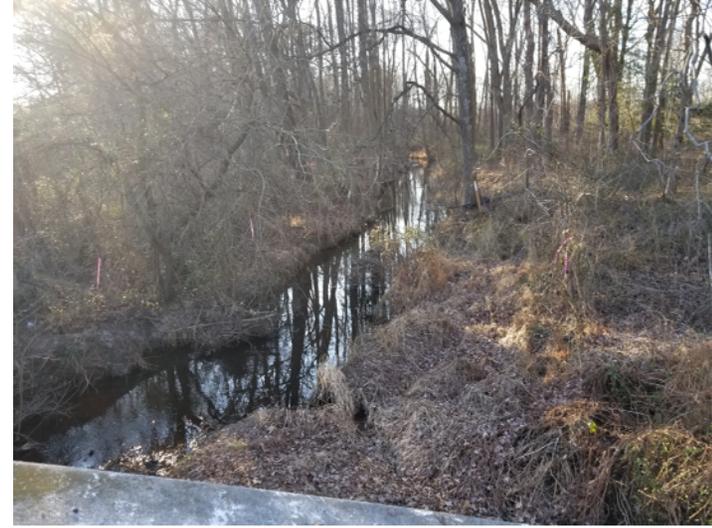
Waterbody B originates east of the project area and conveys flow through a culvert beneath U.S. Route 13 and northwest across the project area, near milepost 1.64, north of Peggy Neck Road. An OHWM and a defined bed and bank were observed within the limits of the stream channel within the project area.

PHOTOGRAPH 2: View of Waters B, facing west.

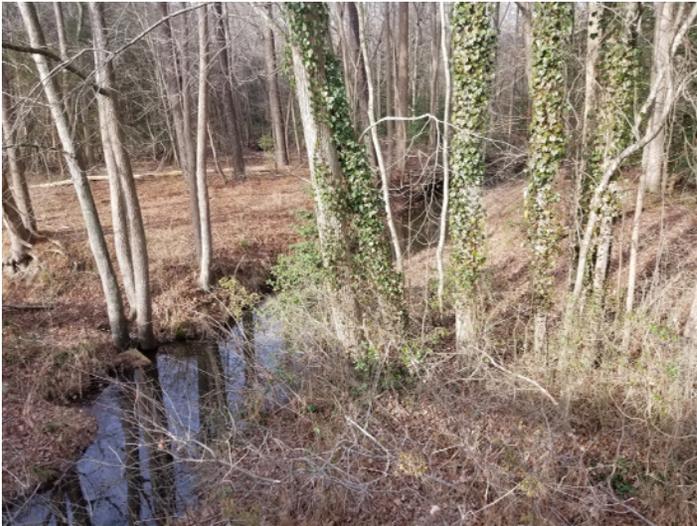
Waterbody C originates east of the project area and conveys flow through a culvert beneath U.S. Route 13 and northwest across the project area, near milepost 2.21. An OHWM and a defined bed and bank were observed within the limits of the stream channel within the project area.

PHOTOGRAPH 3: View of Waters C, facing west.

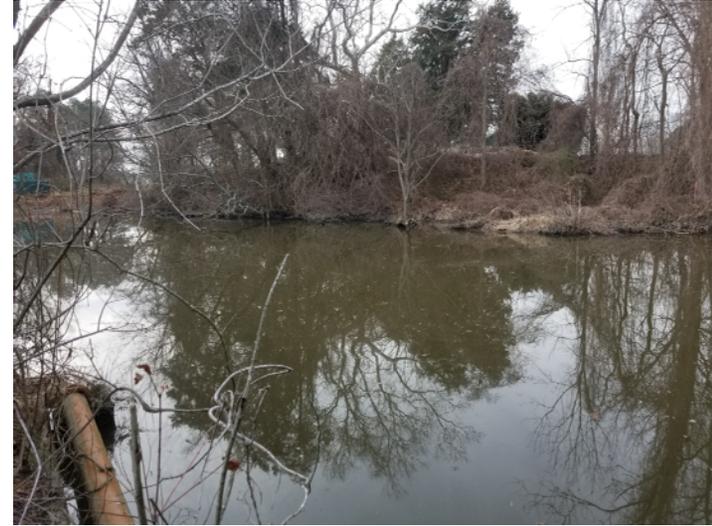
Waterbody D originates east of the review area and conveys flow southwest beneath a bridge conveying U.S. Route 13 and continues west and south outside of the project area. Waterbody D is named the Manokin River, and is a tributary of the Chesapeake Bay. An OHWM and a defined bed and bank were observed within the limits of the stream channel within the project area.

PHOTOGRAPH 4: View of Waters D, Manokin River (tidal), facing north.

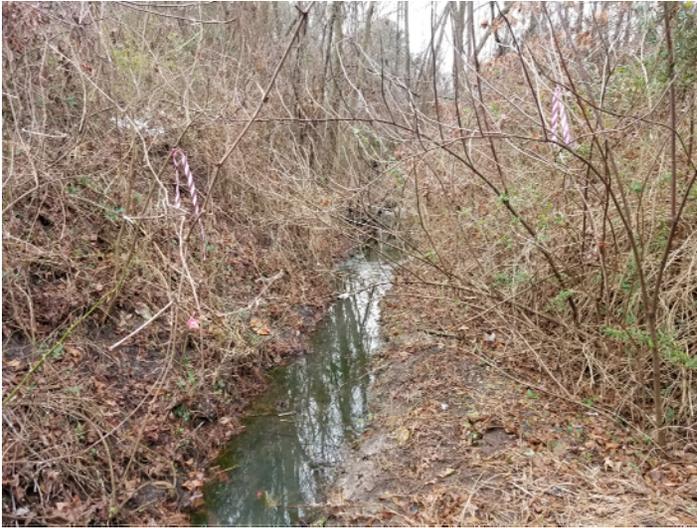
Waterbody E originates east of the project area and conveys flow through a culvert beneath U.S. Route 13 and west across the project area, near milepost 6.70. An OHWM and a defined bed and bank were observed within the limits of the stream channel within the project area.

PHOTOGRAPH 5: View of Waters E, facing west.

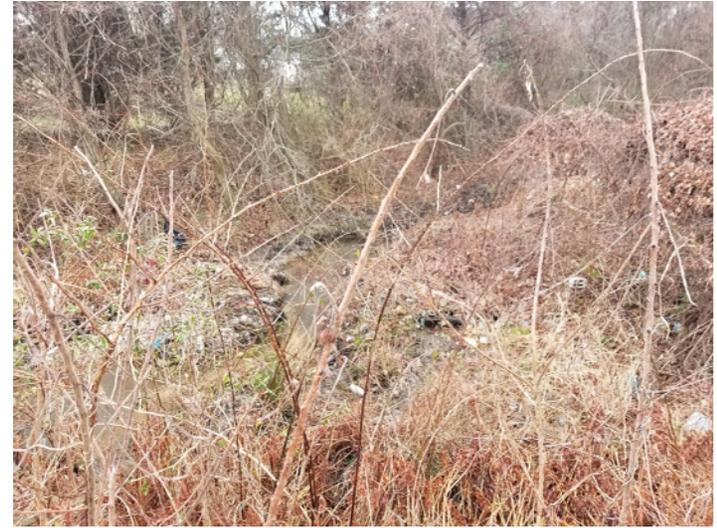
Waterbody F originates east of the project area and conveys flow through a culvert beneath U.S. Route 13 and northwest across the project area, near milepost 6.91, north of Stewart Neck Road. An OHWM and a defined bed and bank were observed within the limits of the stream channel within the project area.

PHOTOGRAPH 6: View of Waters F, facing northwest.

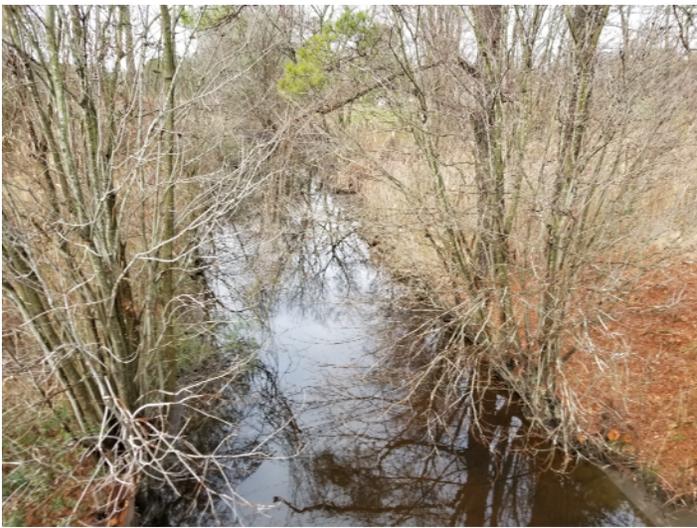
Waterbody G originates east of the project area and conveys flow through a culvert beneath U.S. Route 13 and west across the project area, near milepost 7.59, north of North Central School Road. Waterbody G is named Taylor Branch and is a tributary of the Manokin River. An OHWM and a defined bed and bank were observed within the limits of the stream channel within the project area.

PHOTOGRAPH 7: View of Waters G, Taylor Branch (tidal), facing west.

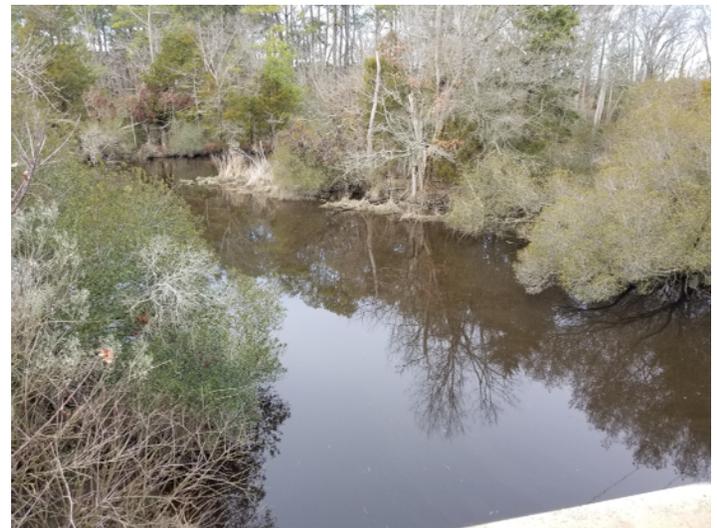
Waterbody H originates east of the project area and conveys flow through a box culvert beneath U.S. Route 13 and west across the project area, near milepost 8.86, north of Perry Road. Waterbody H is named Kings Creek and is a tributary of the Manokin River. An OHWM and a defined bed and bank were observed within the limits of the stream channel within the project area.

PHOTOGRAPH 8: View of Waters H, Kings Creek (tidal), facing west.

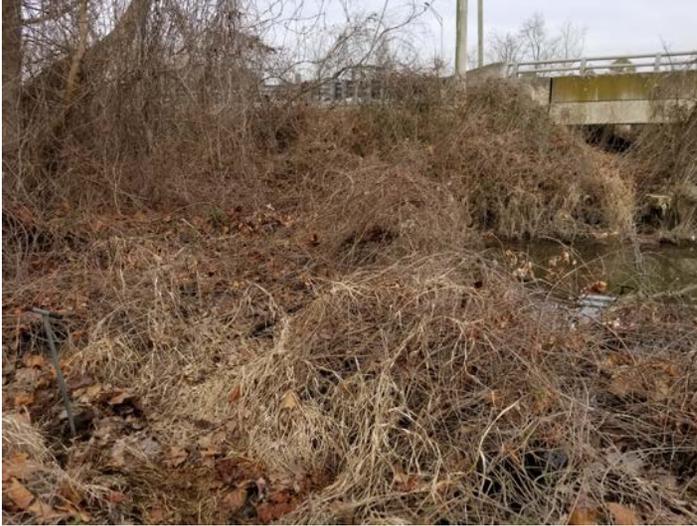
Wetland 1 is an emergent wetland abutting the north bank of Waterbody D (Manokin River). Wetland 1 is located slightly outside of the project area. It should be noted that according to Chapter 26.23.06.02 of the Code of Maryland Regulations (COMAR), as well as correspondence with the Maryland Department of Natural Resources (DNR), this wetland is designated as a Wetland of Special State Concern. Within Wetland 1, GTA's wetland scientists observed predominantly hydrophytic vegetation, including sweetgum (*Liquidambar styraciflua*, FAC), narrowleaf cattail (*Typha angustifolia*, OBL), and crimsoneyed rosemallow (*Hibiscus moscheutos*, OBL). Evidence of primary indicators of wetland hydrology observed by GTA's wetland scientists included indicators A2 (High Water Table), A3 (Saturation), and B3 (Drift Deposits). GTA personnel excavated test pits to depths of 20 inches within the limits of the wetland boundary and observed the NRCS and Corps hydric soils field indicator F3 (Depleted Matrix).

PHOTOGRAPH 9: View of Wetland 1, facing northeast.

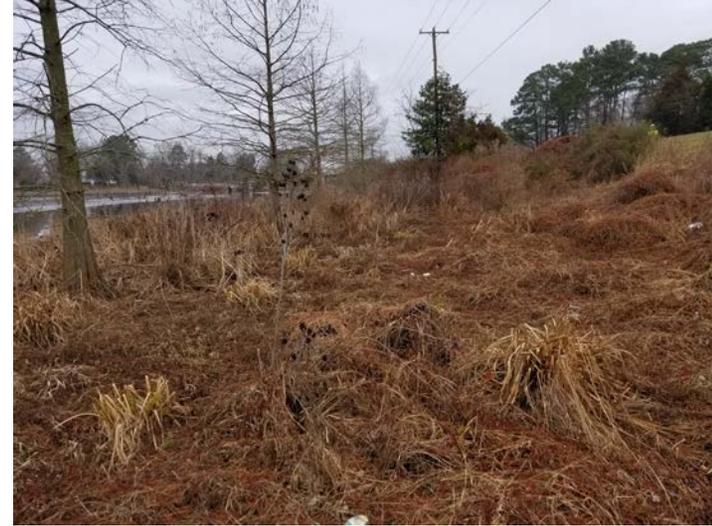
Wetland 2 is an emergent wetland located west of U.S. Route 13, and south of Deal Island Road. Wetland 2 abuts the Manokin River, and consists of both tidal and nontidal portions. The nontidal portion of Wetland 2 is located slightly outside of the project area. Within the vegetation plot, GTA's wetland scientists observed predominantly hydrophytic vegetation species, including bald cypress (*Taxodium distichum*, OBL), crimsoneyed rosemallow, Pennsylvania smartweed (*Polygonum pennsylvanicum*, FACW), and narrowleaf cattail. Evidence of primary indicators of wetland hydrology observed by GTA's wetland scientists included indicators A2 (High Water Table), A3 (Saturation), and B3 (Drift Deposits). GTA personnel excavated test pits to depths of 20 inches within the limits of the wetland boundary and observed the NRCS and Corps hydric soils field indicator A9 (1 cm Muck).

PHOTOGRAPH 10: View of Wetland 2, facing north.

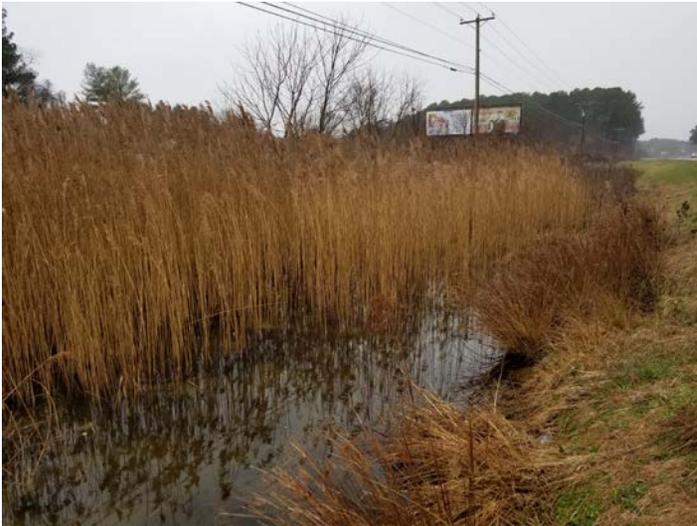
Wetland 3 is an emergent wetland located west of U.S. Route 13 and east of Libby Lane, near milepost 7.35. Within the vegetation plot, GTA's wetland scientists observed predominantly hydrophytic vegetation species, including sweetgum, red maple (*Acer rubrum*, FAC), common reed (*Phragmites australis*, FACW), and common rush (*Juncus effusus*, OBL).

Evidence of primary indicators of wetland hydrology observed by GTA's wetland scientist included indicators A1 (Surface Water), A2 (High Water Table), A3 (Saturation), and B9 (Water Stained Leaves). Evidence of secondary indicators of wetland hydrology observed included indicators D2 (Geomorphic Position) and D5 (positive FAC-Neutral Test). GTA personnel excavated test pits to depths of 20 inches within the limits of the wetland boundary and observed the NRCS and Corps hydric soils field indicator F3 (Depleted Matrix).

PHOTOGRAPH 11: View of Wetland 3, facing northwest.

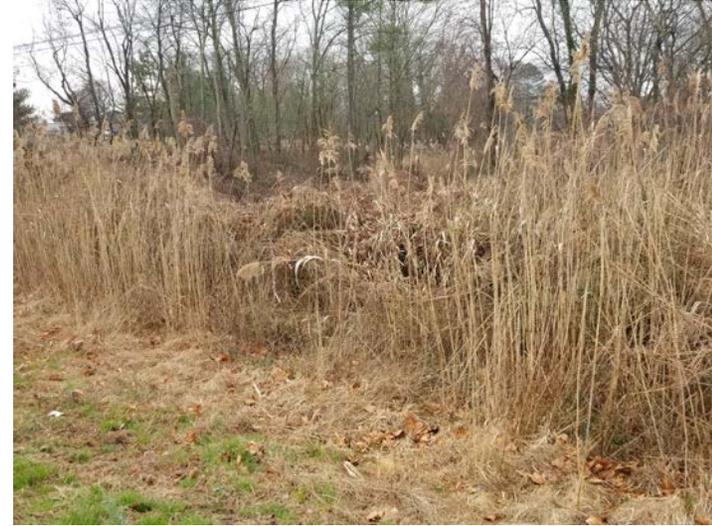
Wetland 4 is an emergent wetland located west of U.S. Route 13, and north of North Central School Road. Wetland 4 abuts Taylor Branch, and consists of both tidal and nontidal portions, within the project area. It should be noted that according to COMAR Chapter 26.23.06.02, as well as correspondence with the DNR, this wetland is considered a Wetland of Special State Concern. Within the vegetation plot, GTA's wetland scientists observed predominantly hydrophytic vegetation species, including red maple, boxelder (*Acer negundo*, FAC), redosier dogwood (*Cornus sericea*, FACW), common reed, and common rush. Evidence of primary indicators of wetland hydrology observed by GTA's wetland scientists included indicator A3 (Saturation). Evidence of secondary indicators of wetland hydrology observed included indicators C9 (Saturation Visible on Aerial Imagery), and D5 (positive FAC-Neutral Test). GTA personnel excavated test pits to depths of 20 inches within the limits of the wetland boundary and observed the NRCS and Corps hydric soils field indicator F3 (Depleted Matrix).

PHOTOGRAPH 12: View of Wetland 4, facing south.

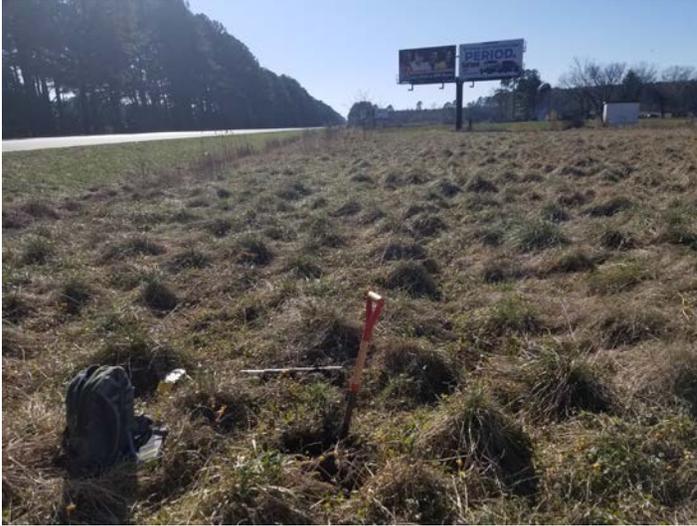
PHOTOGRAPH 13: DCP-1, overview.

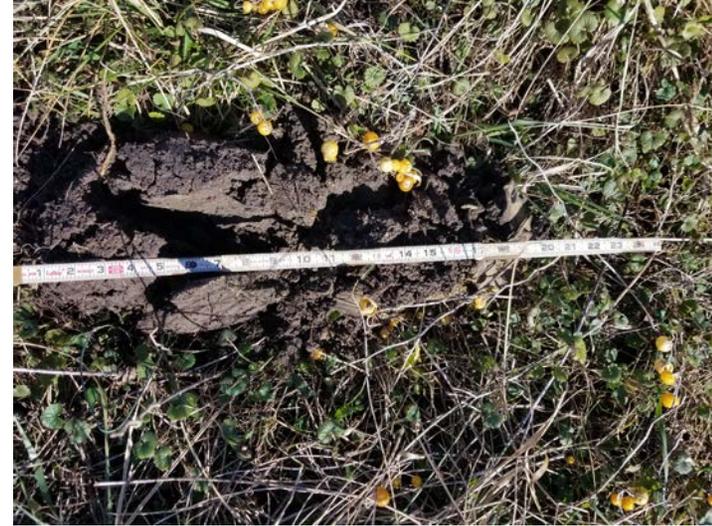
PHOTOGRAPH 14: DCP-1, soil sample.

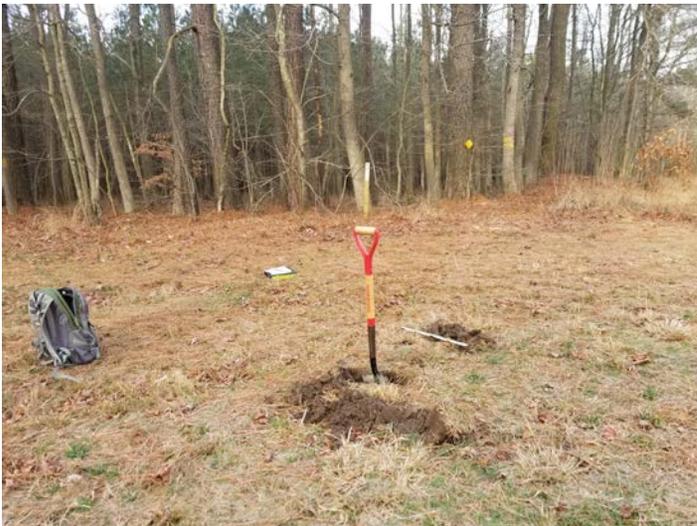
PHOTOGRAPH 15: DCP-2, overview.

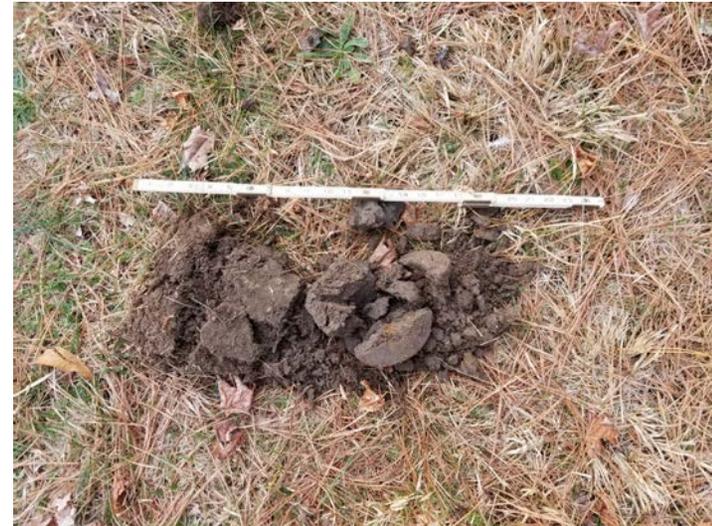
Depth (inches)	Matrix		Redox Features				Texture	Remarks
	Color (moist)	%	Color (moist)	%	Type ¹	Loc ²		
0-6	10YR 3/2	85	5YR 5/6	15	C	M	silt loam	
6-20	10YR 4/1	80	5YR 5/6	20	C	M	clay loam

PHOTOGRAPH 16: DCP-2, soil sample.

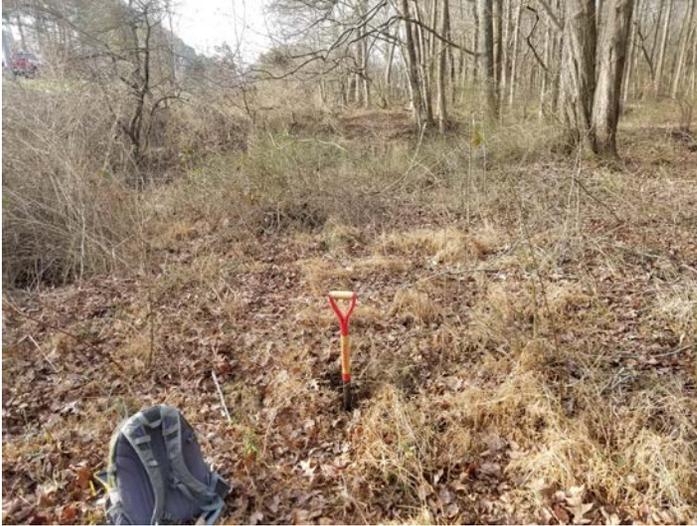
PHOTOGRAPH 17: DCP-3, overview.

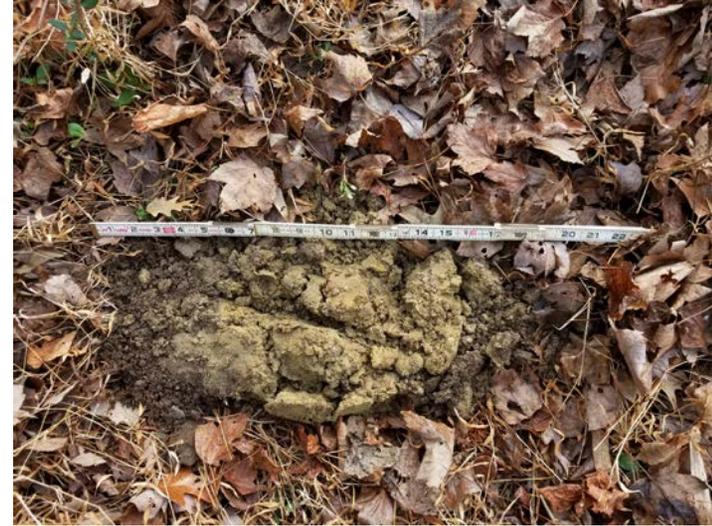
Depth (inches)	Matrix		Redox Features				Texture	Remarks
	Color (moist)	%	Color (moist)	%	Type ¹	Loc ²		
0-6	10YR 3/2	85	5YR 5/6	15	C	M	silt loam	
6-20	10YR 4/1	80	5YR 5/6	20	C	M	clay loam

PHOTOGRAPH 18: DCP-3, soil sample.

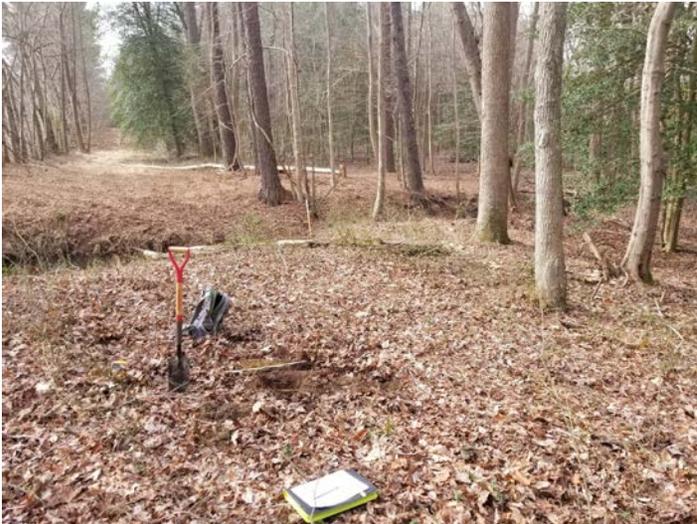
PHOTOGRAPH 19: DCP-4, overview.

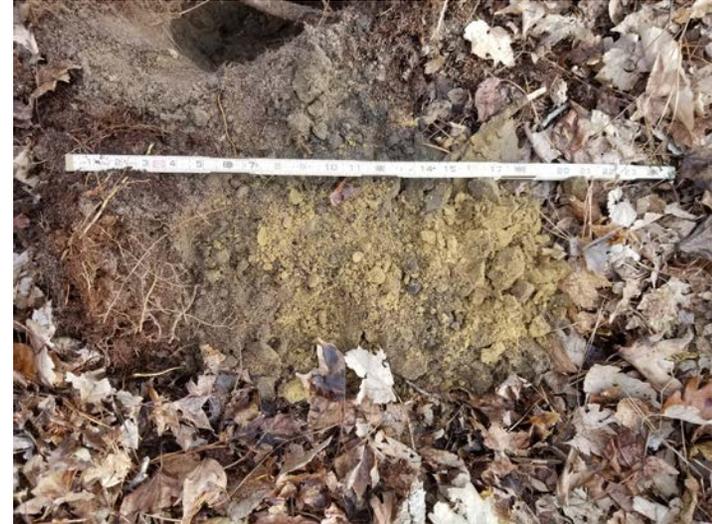
PHOTOGRAPH 20: DCP-4, soil sample.

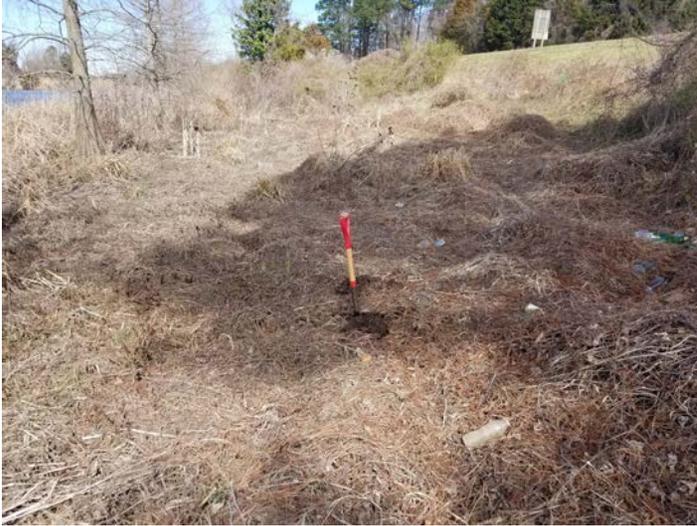
PHOTOGRAPH 21: DCP-5, overview.

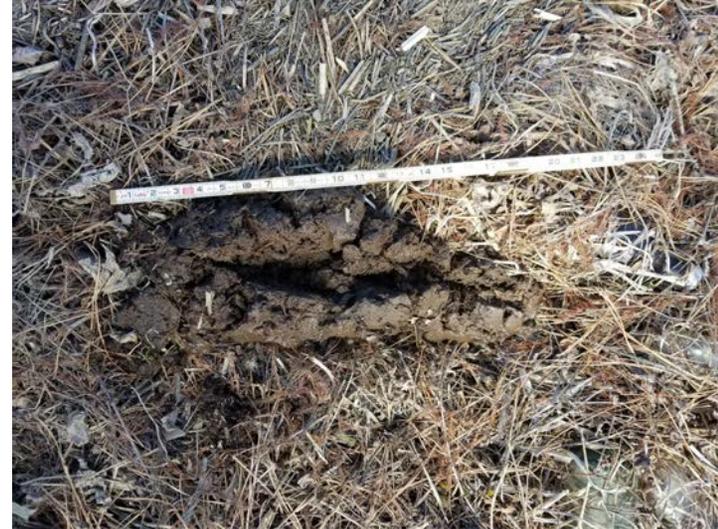
PHOTOGRAPH 22: DCP-5, soil sample.

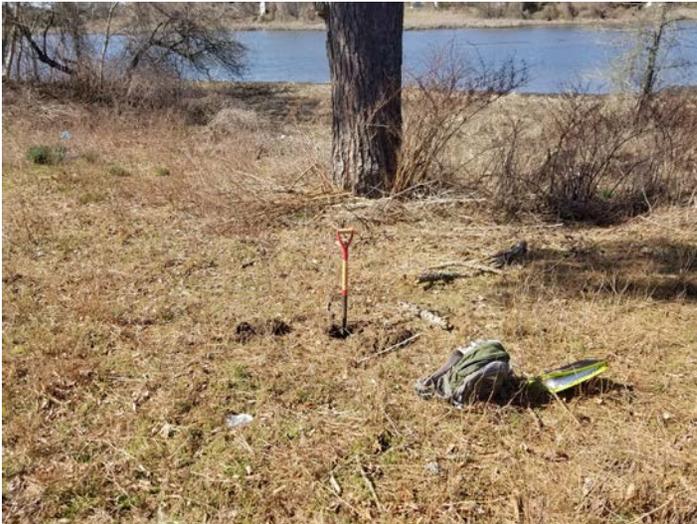
PHOTOGRAPH 23: DCP-6, overview.

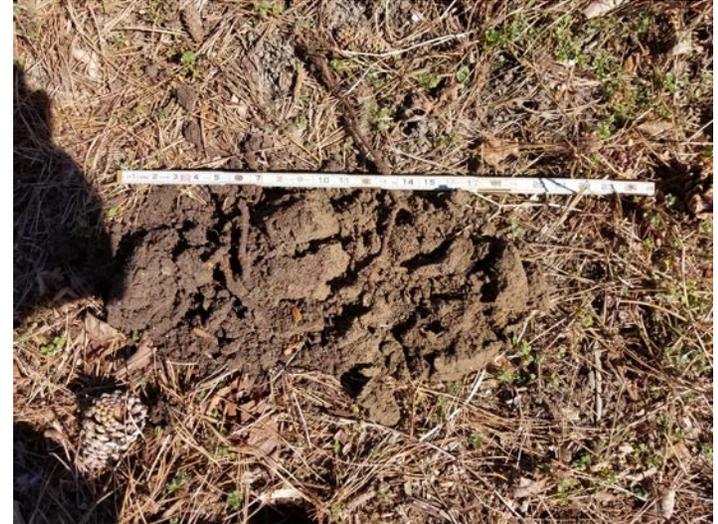
PHOTOGRAPH 24: DCP-6, soil sample.

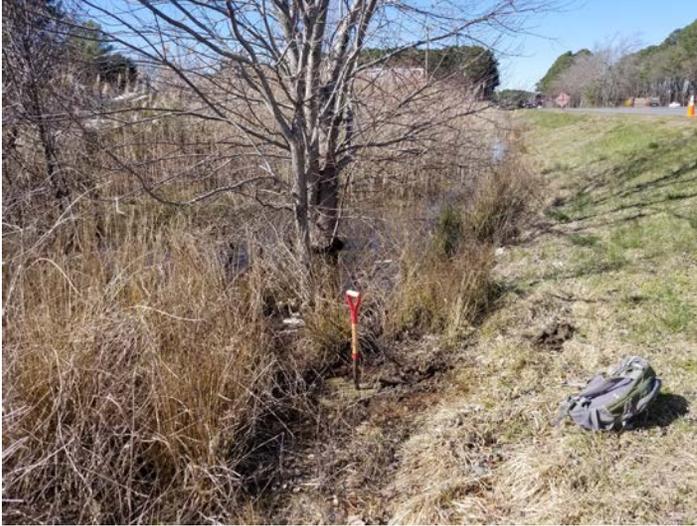
PHOTOGRAPH 25: DCP-7, overview.

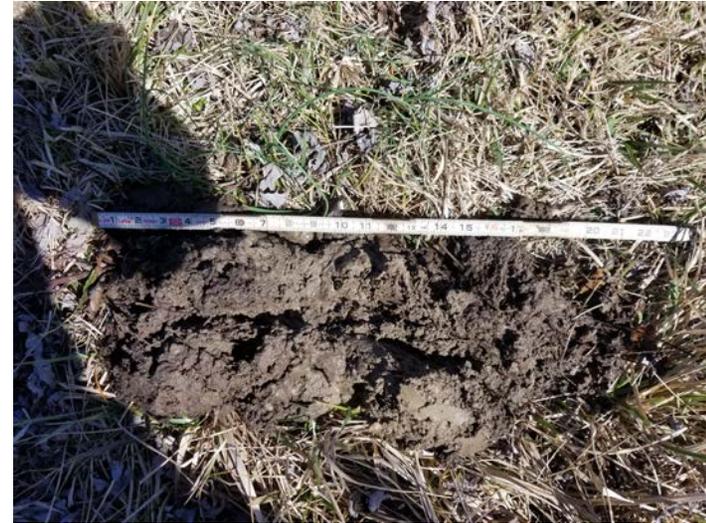
PHOTOGRAPH 26: DCP-7, soil sample.

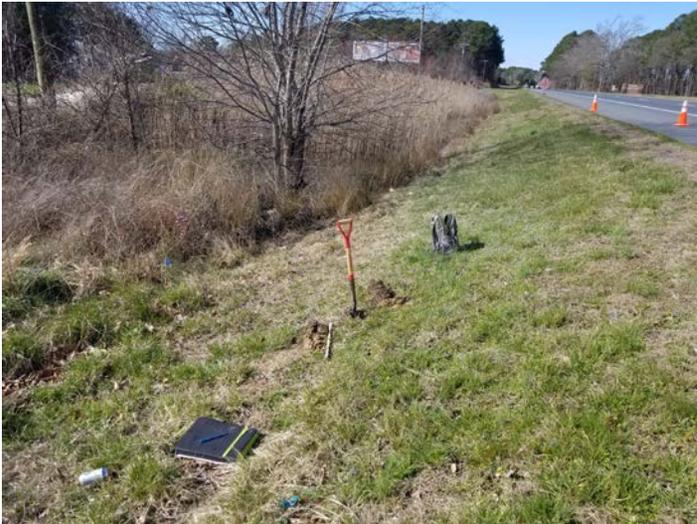
PHOTOGRAPH 27: DCP-8, overview.

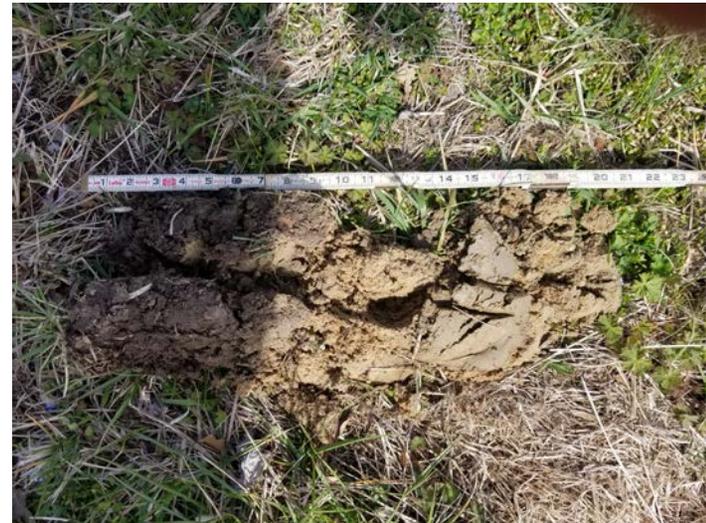
PHOTOGRAPH 28: DCP-8, soil sample.

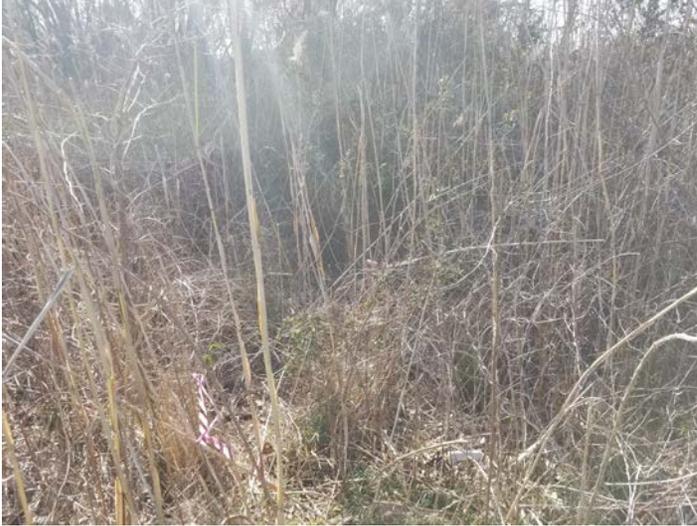
PHOTOGRAPH 29: DCP-9, overview.

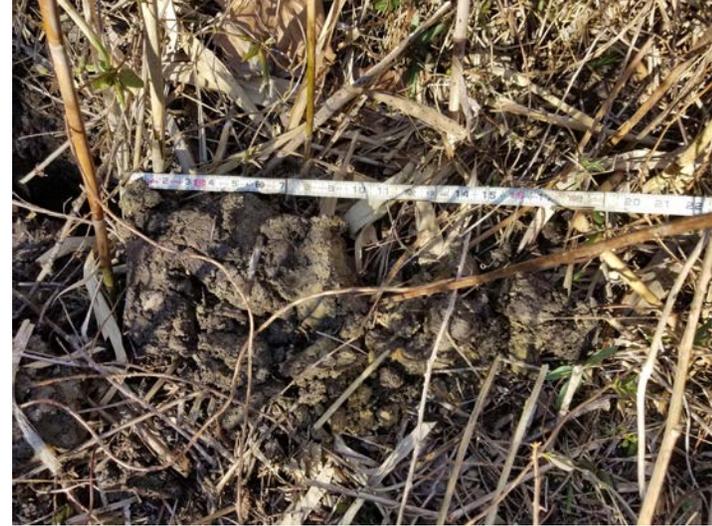
PHOTOGRAPH 30: DCP-9, soil sample.

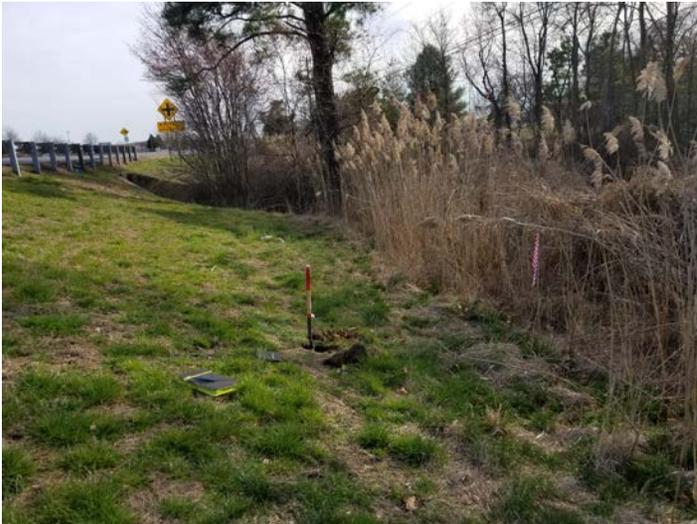
PHOTOGRAPH 31: DCP-10, overview.

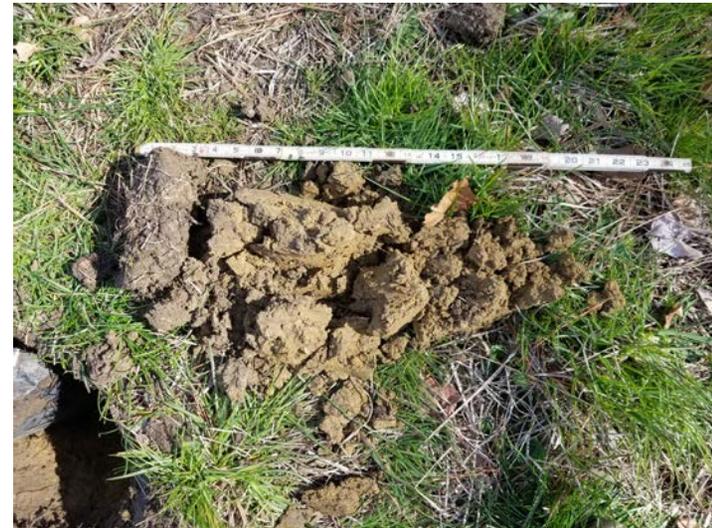
PHOTOGRAPH 32: DCP-10, soil sample.

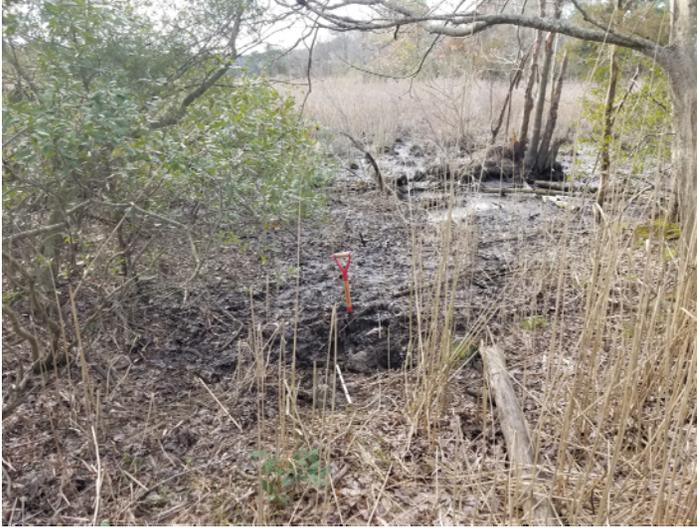
PHOTOGRAPH 33: DCP-11, overview.

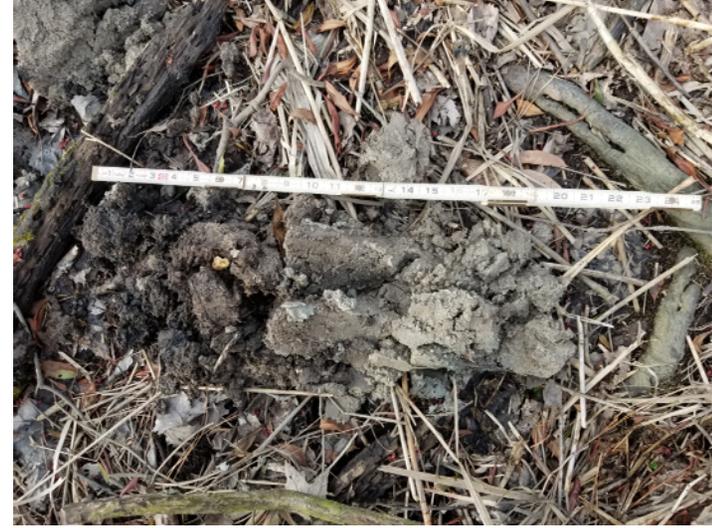
PHOTOGRAPH 34: DCP-11, soil sample.

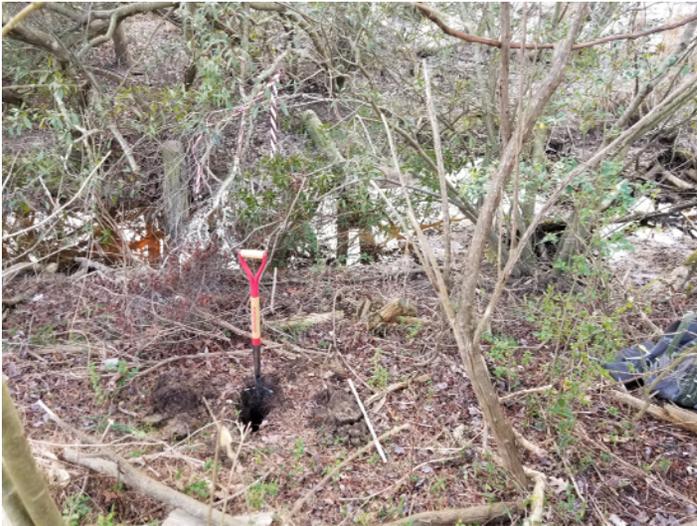
PHOTOGRAPH 35: DCP-12, overview.

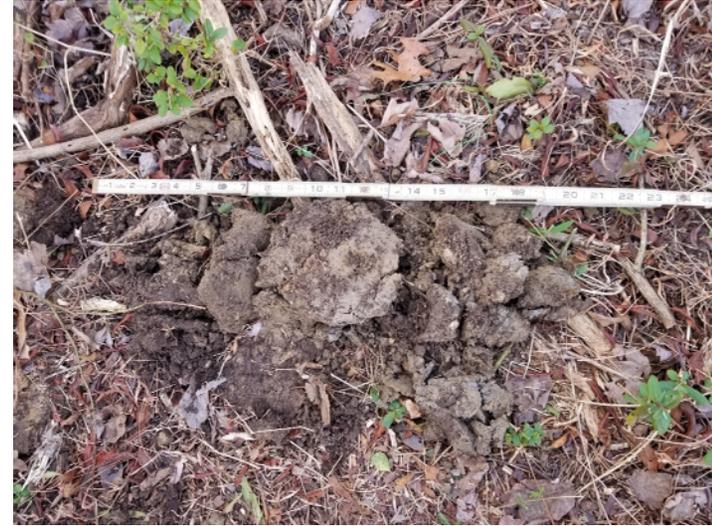
PHOTOGRAPH 36: DCP-12, soil sample.

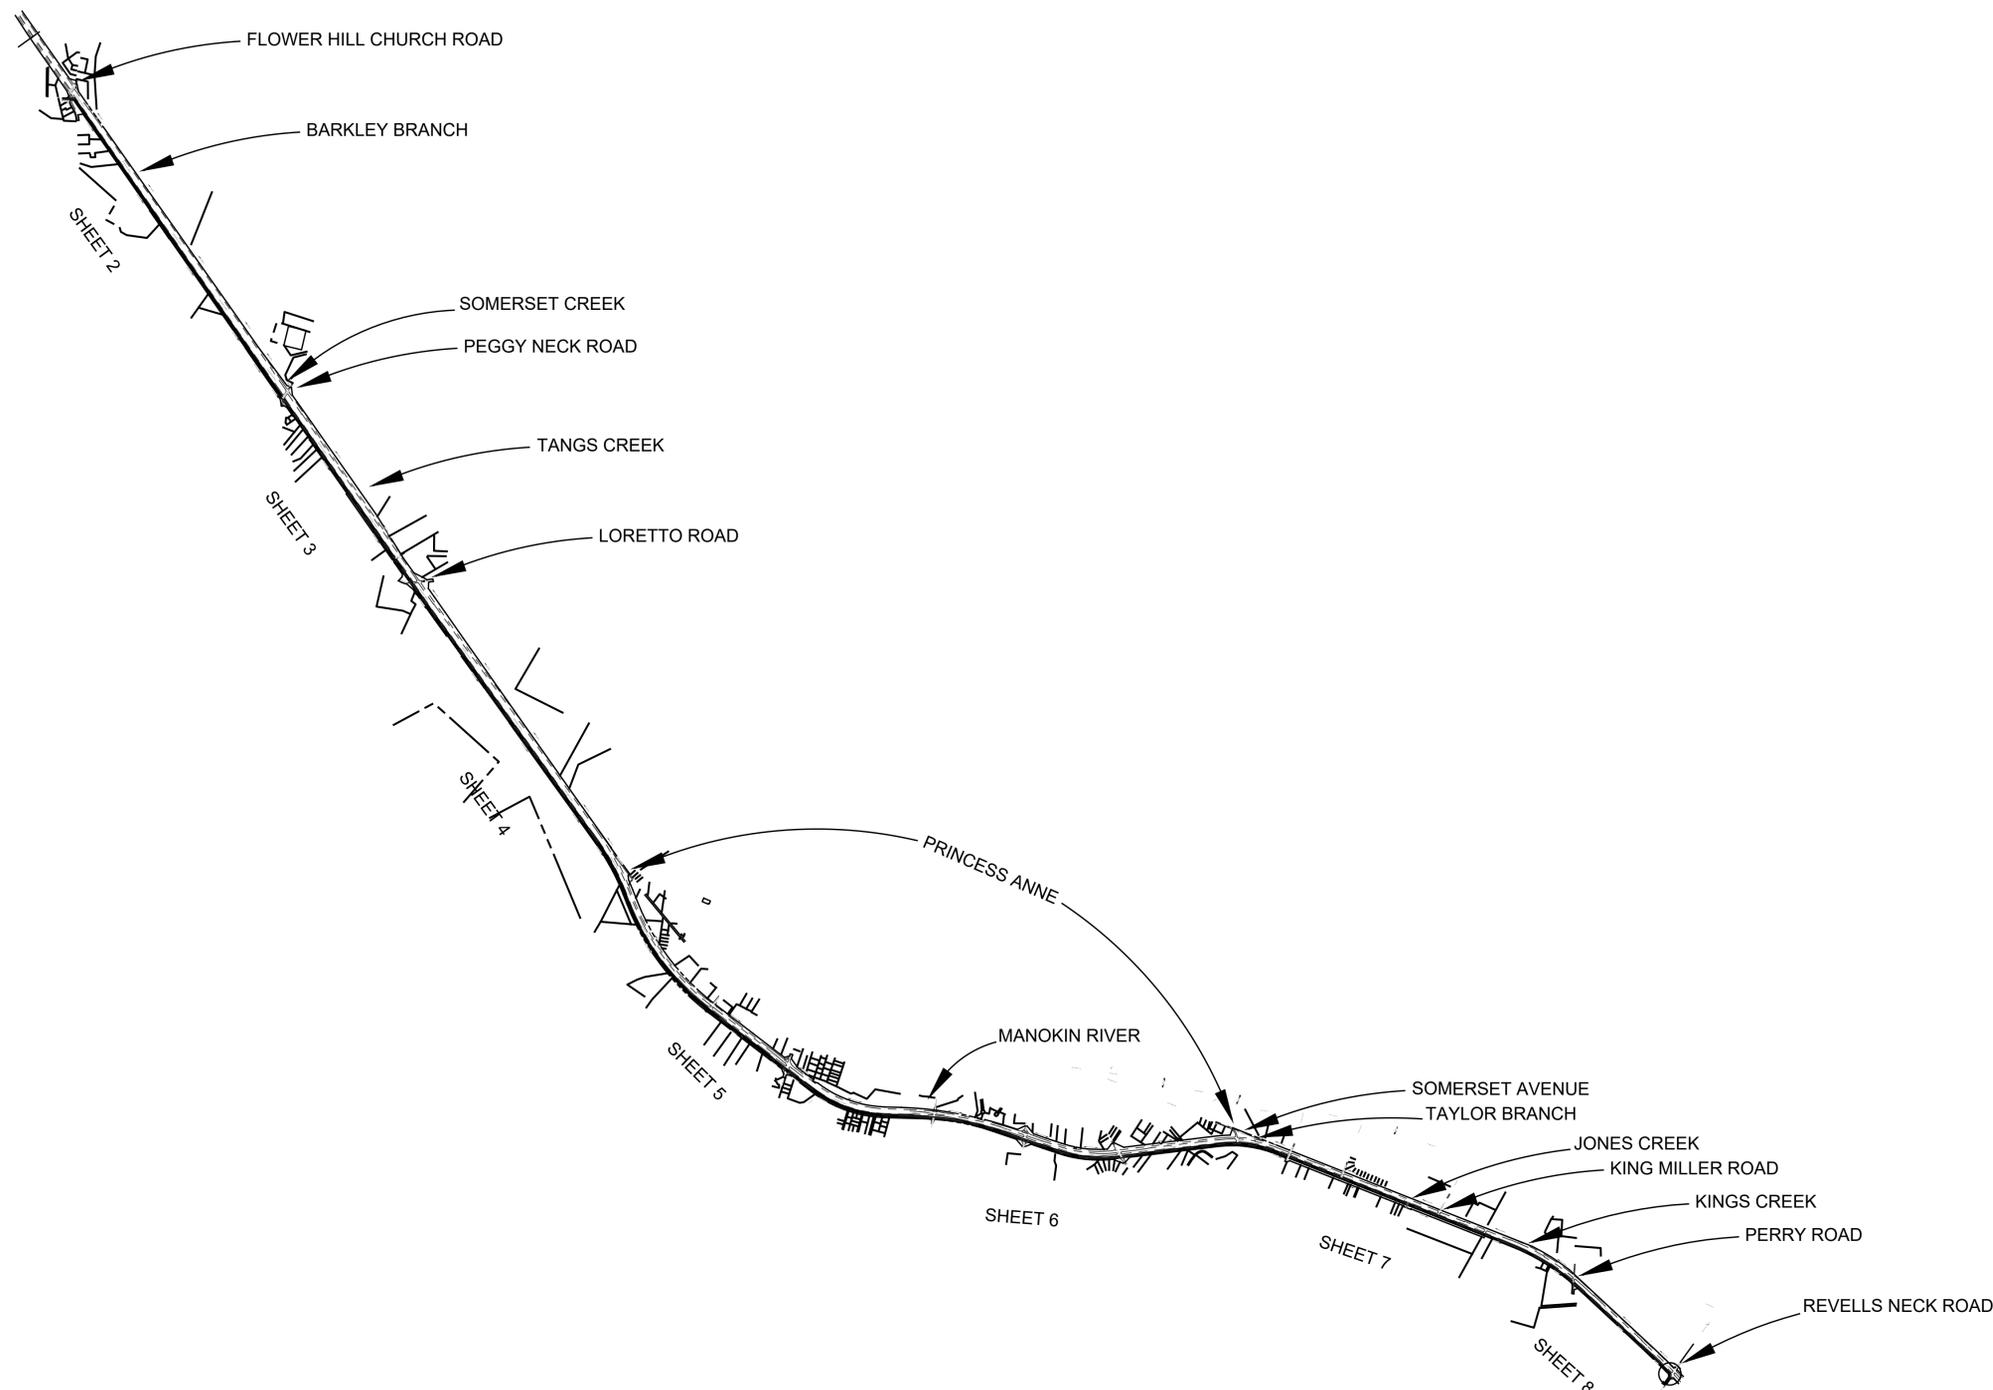
<table><tr> <td style="font-size: small;">DRAWN BY</td> <td style="font-size: small;">JDT</td> <td style="font-size: small;">5/20/2019</td> </tr><tr> <td colspan="3" style="text-align: center; font-size: small;">SHEET 1 OF 8</td> </tr></table>

<p>WETLAND DELINEATION PLAN REVISED MARCH 18, 2020 TO INCLUDE ADDITIONAL WETLAND DELINEATION INFORMATION</p>		<p>GEO-TECHNOLOGY ASSOCIATES, INC. GEOTECHNICAL AND ENVIRONMENTAL CONSULTANTS 3445-A BOX HILL CORPORATE CENTER DRIVE ABINGDON, MD 21009 TEL: (410) 515-9446 FAX: (410) 515-4895 MRAGTA.COM</p>			<p>CONCEPT SOMERSET COUNTY GAS MAIN EXPANSION SCHEMATIC DESIGN DRAWING (PRINCESS ANNE, MARYLAND)</p>
